STOP WATER INFLOW

NASSCO REPORT: MANHOLES

Long term Performance of Mechanical Manhole Frame-Chimney Seals

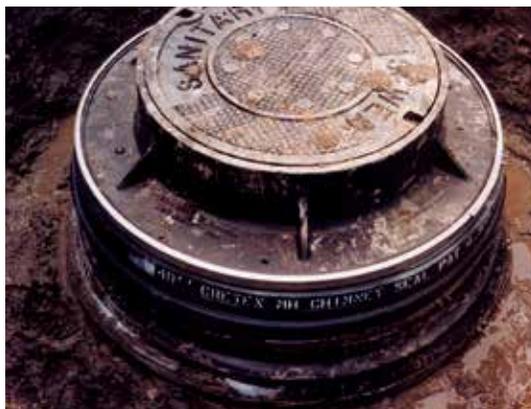
CRETEX EXTERNAL SEAL

these problems from happening by installing either an INTERNAL or EXTERNAL CHIMNEY SEAL on all new manholes. Tests have shown that frame-chimney leakage begins within a year or two after construction. The minimal initial cost of putting a chimney seal on all new manholes is far outweighed by the long term cost savings.

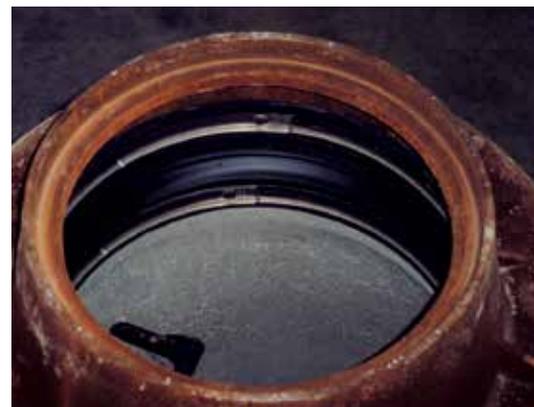
CRETEX INTERNAL SEAL

these problems in existing manholes by installing the INTERNAL CHIMNEY SEAL. Designed to be installed in existing manholes, this seal does not require excavation or entry into the manhole. These internal seals have the versatility to fit virtually any size or type of manhole. Hundreds of thousands of these reusable seals have been installed in brick, block and precast manholes.

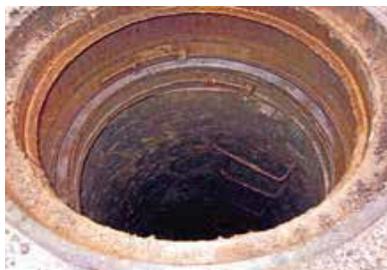
Seal Prior to Removal

In December 2014, one of the oldest known seals was located in a manhole (Basin WA-30) in Wauwatosa, Wis., a suburb of Milwaukee. Based on city records, this seal had been installed as part of an MMSD manhole rehab project in late 1982 or early 1983, making the seal approximately 32 years old. The seal was visually inspected and appeared to be in good condition, with no obvious defects or visible leakage.

The seal and bands were removed; the substrate behind the seal was inspected and was also found to be in relatively

good condition, considering a basic Portland mortar mix was used for surface preparation during the original installation. Today, there are higher quality, more suitable repair materials available for use in these applications.

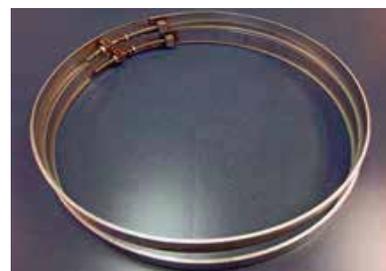
Cleaned Stainless Steel
Bands Prior to Testing

The visual appearance of the stainless steel bands indicated some surface rust, but these areas did not penetrate the base metal and was only a surface condition. Test results on the stainless steel bands indicated that the material met the requirements of ASTM A 240, Type 304 as required in ASTM C 923.
