ARPRO[®]

Expanded Polypropylene (EPP) Foam

UV Exposure Testing

Sewer Ring Program
Black EPP; 120 g/l

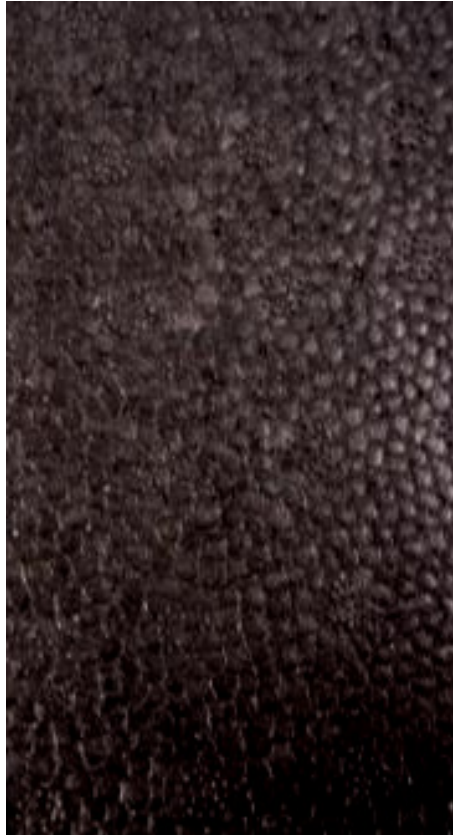
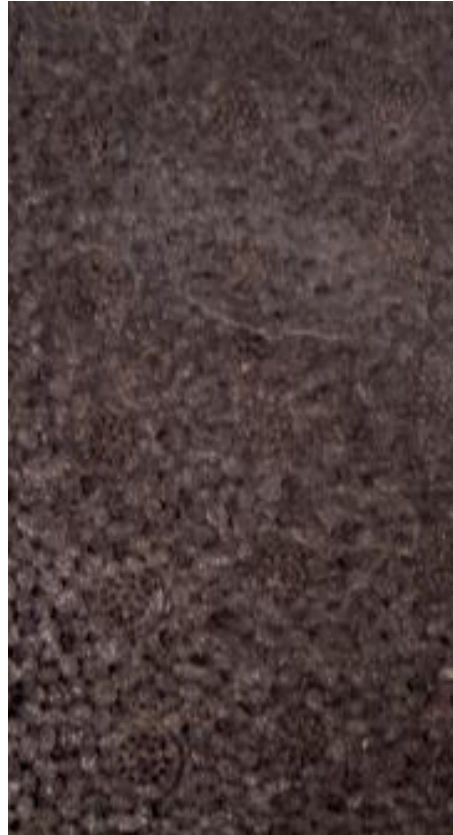
Figure 2

As is evident from the results above, the 12 month equivalent aging result for 120 g/l Black EPP indicated a ΔE of 3.82. A picture the Pre-test and Post-test samples are shown below for comparison. It should be noted that industry standards indicate that a ΔE result >2.5 is the typical threshold of visible differences noted by the human eye. As can be see from the pictures below in Figure 2, some difference is noted, however, the surface of the material exhibits only minor 'chalking' and the material properties are not affected.

Pre-Test UV
Aged Samples

Post-Test UV
Aged Samples
(12 months)
