STOP WATER INFLOW

Cretex
Specialty Products

NASSCO REPORT: MANHOLES

Long term Performance of Mechanical Manhole Frame-Chimney Seals

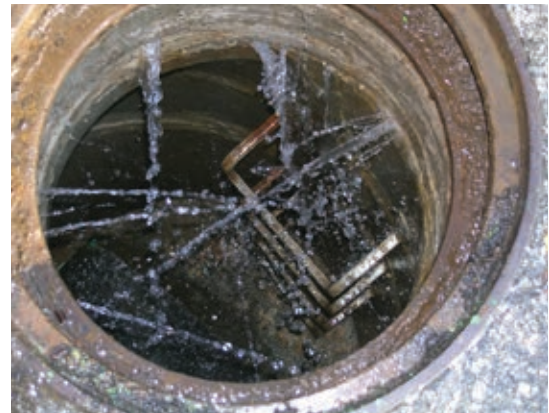
STOP

these problems in existing manholes by installing the INTERNAL CHIMNEY SEAL. Designed to be installed in existing manholes, this seal does not require excavation or entry into the manhole. These internal seals have the versatility to fit virtually any size or type of manhole. Hundreds of thousands of these reusable seals have been installed in brick, block and precast manholes.

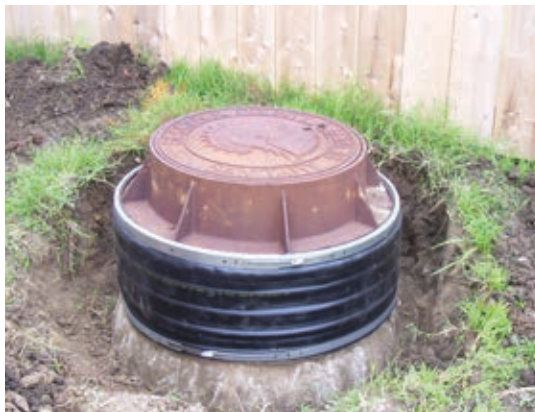
CRETEX EXTERNAL SEAL

these problems from happening by installing either an INTERNAL or EXTERNAL CHIMNEY SEAL on all new manholes. Tests have shown that frame-chimney leakage begins within a year or two after construction. The minimal initial cost of putting a chimney seal on all new manholes is far outweighed by the long term cost savings.

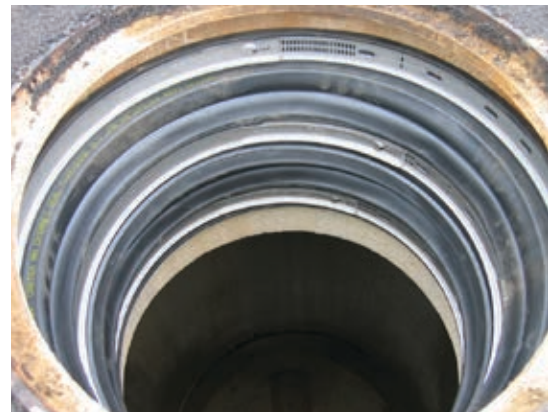
CRETEX INTERNAL SEAL

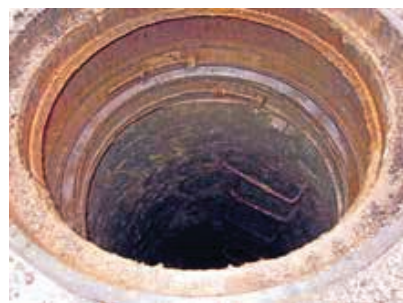
Seal Prior to Removal

In December 2014, one of the oldest known seals was located in a manhole (Basin WA-30) in Wauwatosa, Wis., a suburb of Milwaukee. Based on city records, this seal had been installed as part of an MMSD manhole rehab project in late 1982 or early 1983, making the seal approximately 32 years old. The seal was visually inspected and appeared to be in good condition, with no obvious defects or visible leakage.

The seal and bands were removed; the substrate behind the seal was inspected and was also found to be in relatively

good condition, considering a basic Portland mortar mix was used for surface preparation during the original installation. Today, there are higher quality, more suitable repair materials available for use in these applications.

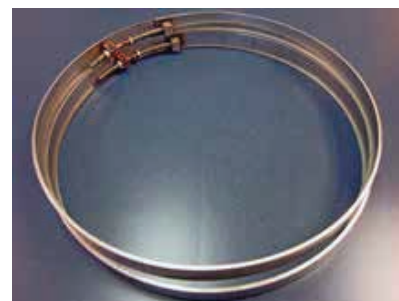
Cleaned Stainless Steel
Bands Prior to Testing

The visual appearance of the stainless steel bands indicated some surface rust, but these areas did not penetrate the base metal and was only a surface condition. Test results on the stainless steel bands indicated that the material met the requirements of ASTM A 240, Type 304 as required in ASTM C 923.
